Phase I Environmental Site Assessment

Former Cocoa Post Office

32 Orange Street

Cocoa, Florida

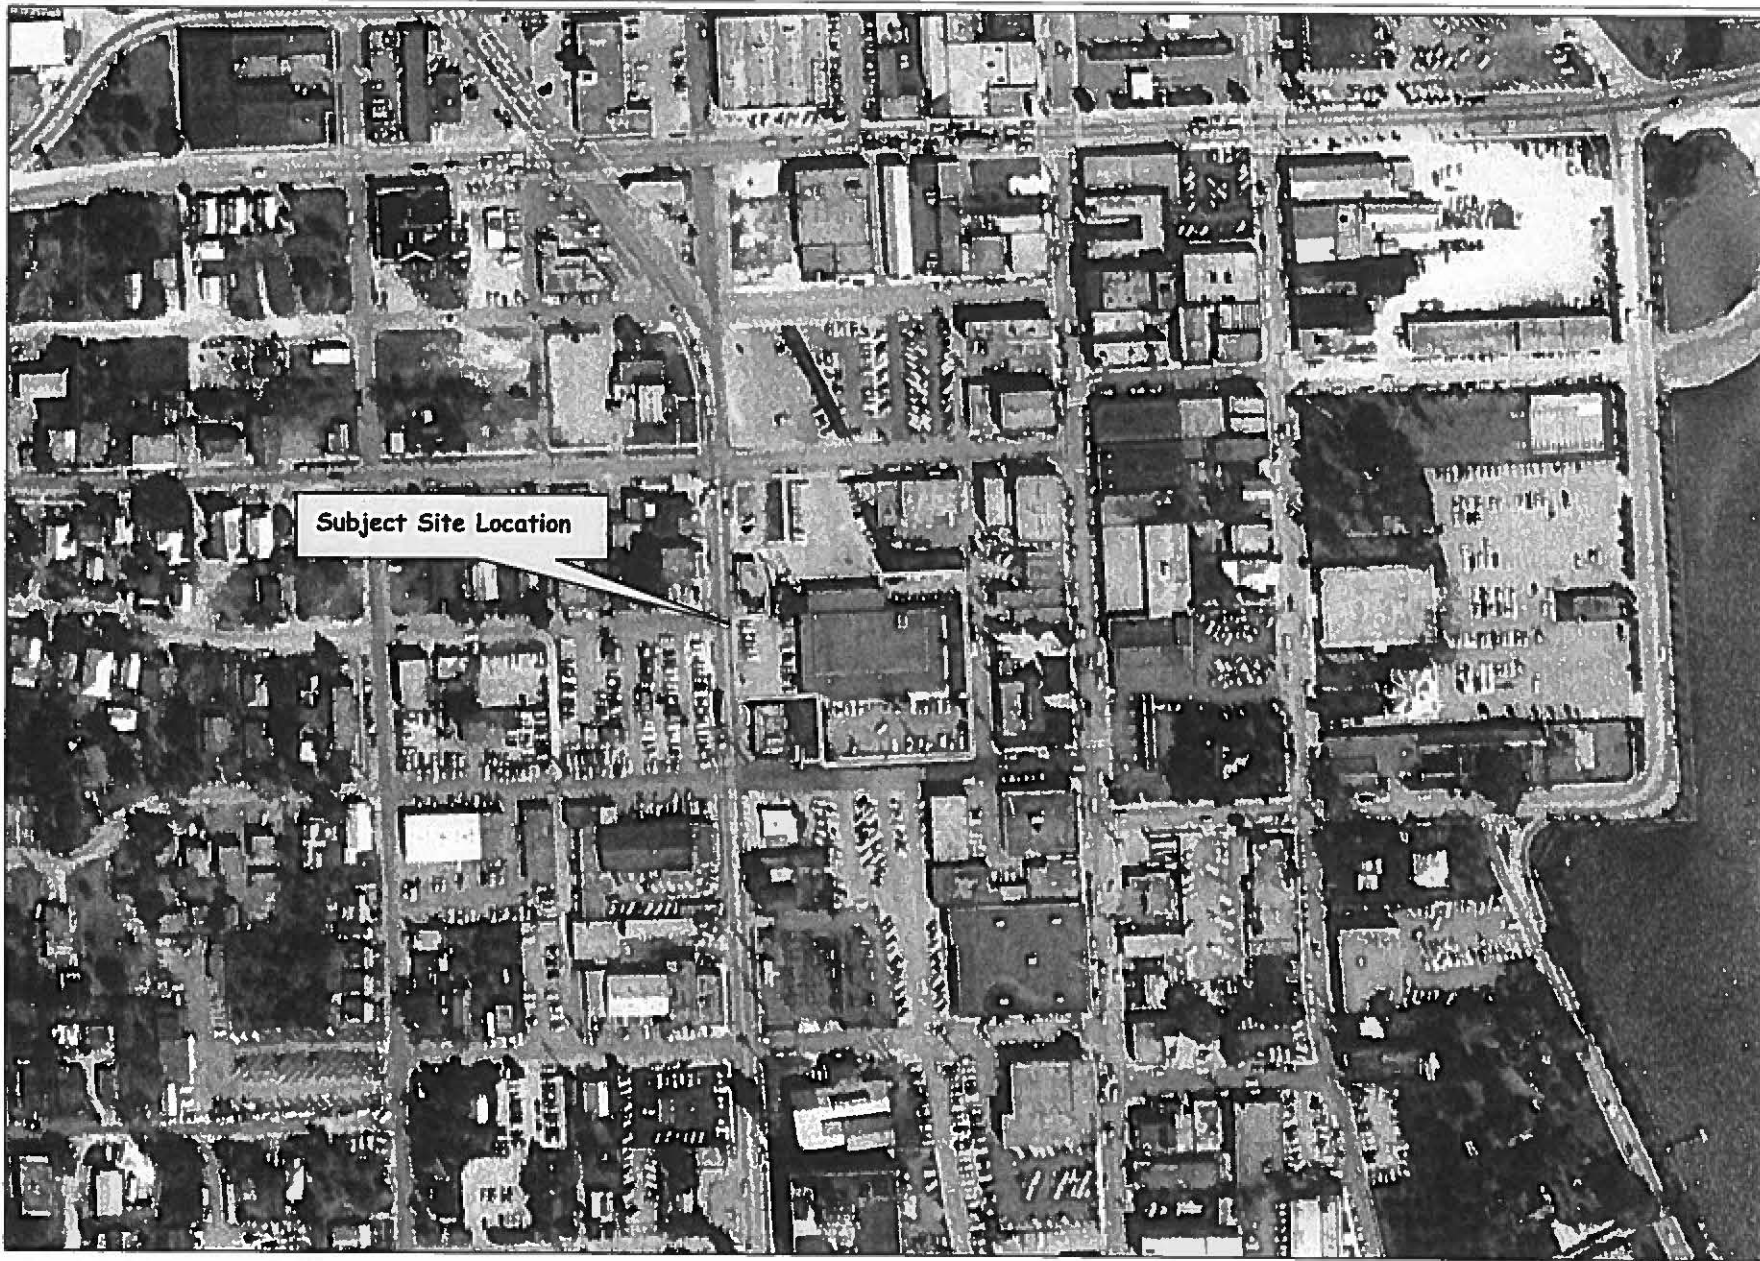
Figure 4d
Aerial Photograph - 1972

- No other significant changes from the previous aerial photograph were noted.
- **1972 (see Figure 4d):**
 - Subject Property:
 - The subject property appears to be developed with the structure and pavement pattern observed during the recent site visit, consistent with County records of the post office structure being built in 1965.

- The small structure observed near the west boundary of the subject site is no longer visible (apparently replaced by the west parking area).
 - No other significant changes from the previous aerial photograph were noted.

- Surrounding Properties:
 - Extensive commercial development is visible throughout the vicinity of the subject site, consistent with structures observed during the recent site visit (with the exception of the structure located at 600 Florida Avenue – adjacent site south).

- The suspected train depot structure observed on the adjacent site north of the subject site in previous aerial photographs is no longer visible.
 - An apparent garage facility is visible approximately 200 feet southwest of the subject site, consistent with site visit observations.

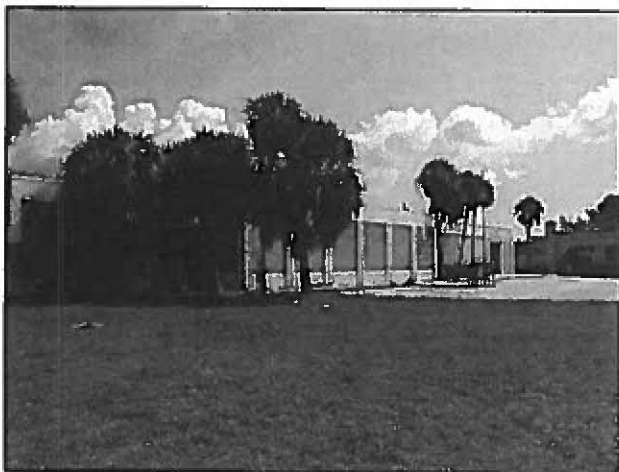
Left: View of the south side (front) of the subject site structure.

Right: View of east paved area and north side of a portion of the on-site structure. Note surface topography, sloping toward Brevard Court.

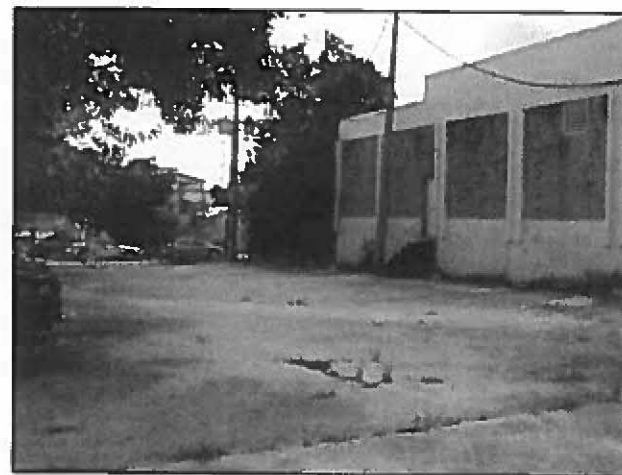
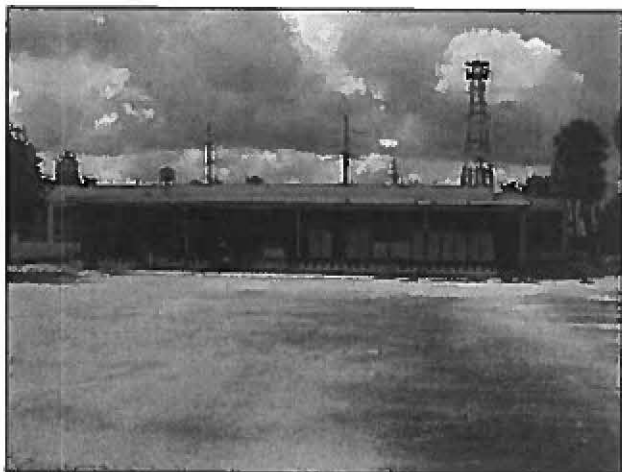
Left: View of north side (rear) of the on-site structure showing loading/delivery area.

Right: View of loading dock.

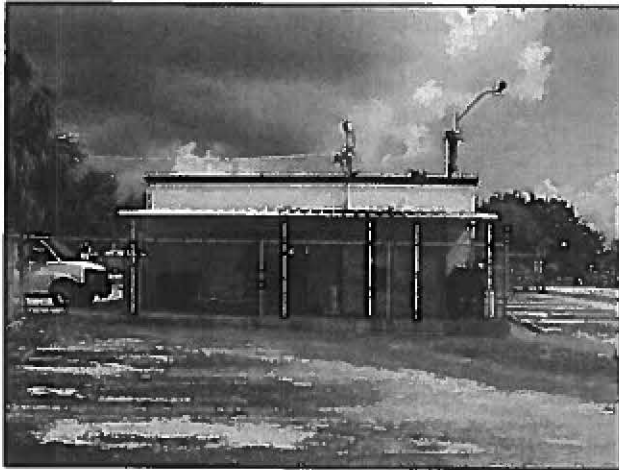
Left: View of the adjacent dry cleaning facility with suspected surface impacts extending onto the subject site. Note subject site boundary is the chain-link fence.

View of commercial structures located on adjacent parcel to the northeast (former dry cleaning facility location)

Based on the recognized environmental conditions, TBE recommends **further assessment** of the subject property; including:

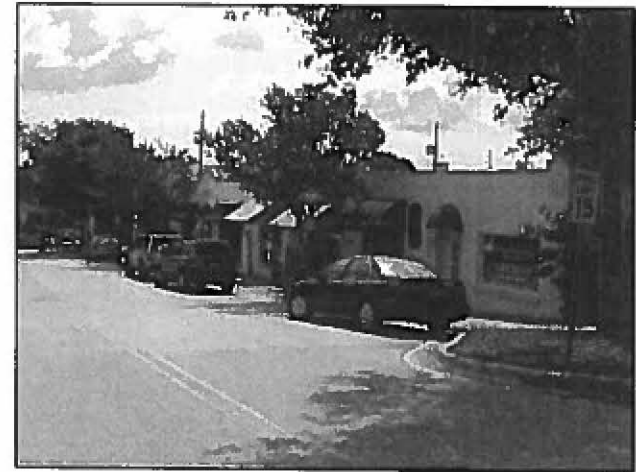
Left: View of adjacent garage apparently associated with the commercial structures in the above-right photo.

Right: View of former retail gasoline facility located approximately 200 feet upgradient of the subject site.
